Release Notes

System Software 10.2.10

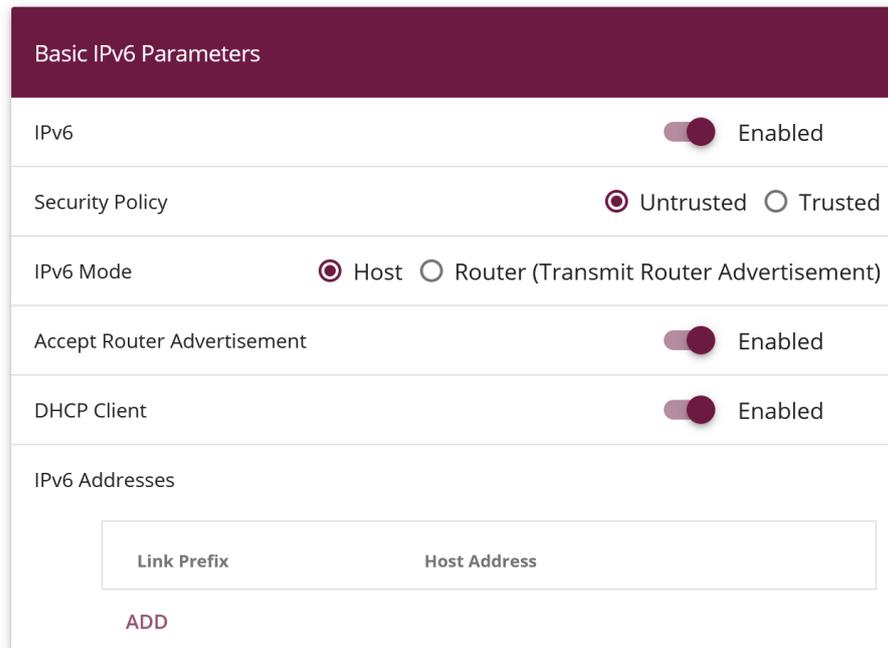
- **Internet connections via IPv6 (#5411)** - If an Internet connection was established via IPv6 and DHCP, problems could occur if an IPv6 address was initially transmitted to the device, but then the execution of SLAAC was signaled. The bintec elmeg device then released the obtained address again. This problem can be prevented with the following settings:

- Make sure that in the **LAN > IP Configuration** menu, the interface over which the connection is established is set up as a DHCPv6 client:
